BELZONA SUPERWRAP II PATCHES SEAWATER BULK MEDIA FILTER VESSEL

ID: 5574

Industry: Oil & Gas
Application: SOS-Ships and Offshore Structures

Customer Location: Gulf of Mexico, USA
Application Date: March 2015

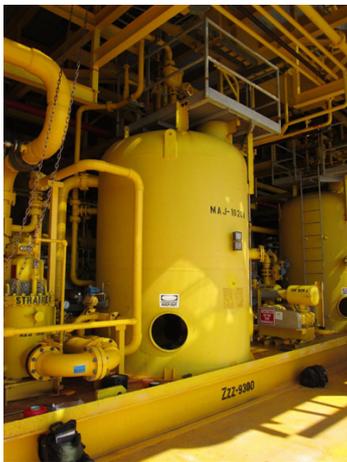
Damage to the external part of the bottom of the vessel due to corrosive environment and seawater transported in the vessel.

Seawater bulk media filter vessel on offshore Oil and Gas platform.
