# BELZONA SUPERWRAP II PATCHES SEAWATER BULK MEDIA FILTER VESSEL

ID: 5574

Industry: Oil & Gas  
Application: SOS-Ships and Offshore Structures

Customer Location: Gulf of Mexico, USA  
Application Date: March 2015

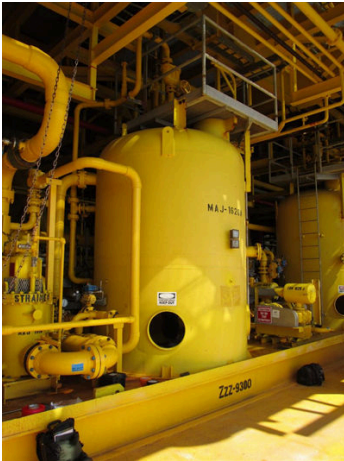
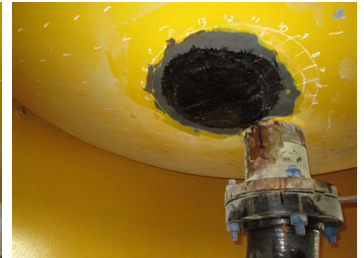
Damage to the external part of the bottom of the vessel due to corrosive environment and seawater transported in the vessel.

- \* Seawater Bulk Media Filter Vessel ,
- \* After abrasive blasting ,
- \* Belzona 1212 used to patch over thin wall area and sealed through-wall defect ,
- \* Belzona Superwrap II applied as per engineered design ,

The application was carried out in accordance with a modified Belzona Know-How System Leaflet SOS-5 for Reinforcing Cargo Tank Bottoms. The bolt plugging the hole was removed, water drained, and the defected area was exposed. The through-wall defect was sealed with Belzona 1291 and thinned areas were rebuilt with Belzona 1212. The substrate was then cleaned to the requirements of SSPC SP 10 (Near-White Metal) by abrasive blasting. Three wraps (6 layers) of Belzona Superwrap II were applied to the repair area according to design. SuperWrap II repair was consolidated by applying pressure against a curved surface made of Belzona 1121.
