STRUCTURAL REINFORCEMENT TO NAPHTHA TOWER WITH BELZONA TECHNOLOGY

ID: 5577

Customer Location: Refinery, Brazil

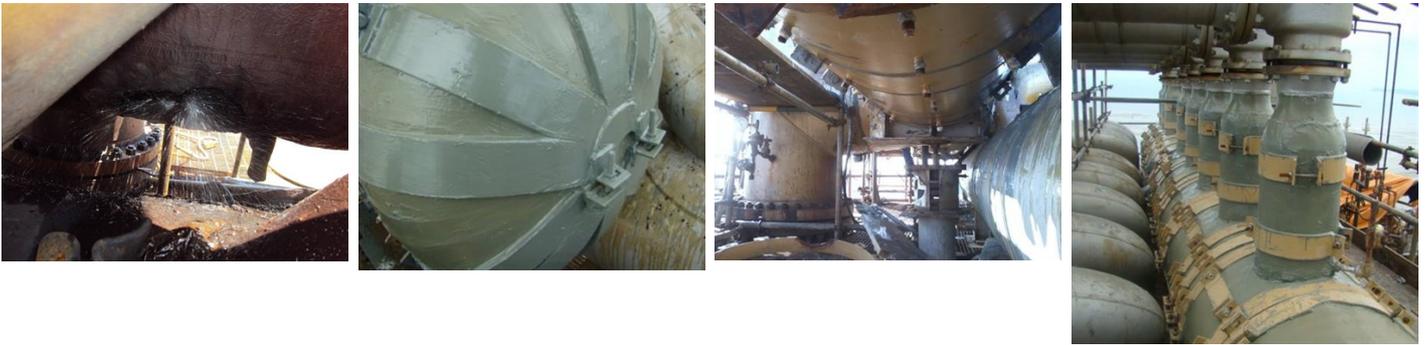
Photograph Descriptions

Leaking naphtha due to the presence of holes in the inferior generatrix.

- * Naphtha leak at the lower generatrix ,
- * Installation of the structural reinforcement of the cover with Belzona 1511 ,
- * Structural reinforcement installed in the lower generatrix with Belzona 1391 ,
- * Completed application ,

The surface preparation was carried out through abrasive blasting of the pre-fabricated parts and grinding of the fiberglass substrate and metal parts of the equipment. Then, Belzona 1511 was applied to the upper generatrix with a stainless steel reinforcement sheet for fastening the tie rods and sealing the plates of the lower generatrix. Belzona 1391 was injected in the lower generatrix for a better accommodation with regards to the peripheral imperfections of the fiberglass.

The naphtha accumulator has been previously repaired with fiberglass, a procedure that was not effective and displayed holes in the fiber. Belzona guaranteed to enclose the system with an operating temperature of 115°C and operating pressure of 400 gf/cm², exceeding several critical points, such as the location of the accumulator at the top of the tower at 86 m in height and hoisting 70 kg parts to the top. Inspection was carried out in February of 2015 and it was verified that the installed system is still working well.
