# BELZONA REBUILD AND PROTECTS TURBINE RUNNER

ID: 5579

Customer Location: Hydropower Plant, British Columbia, CA  
Application Date: May 2001

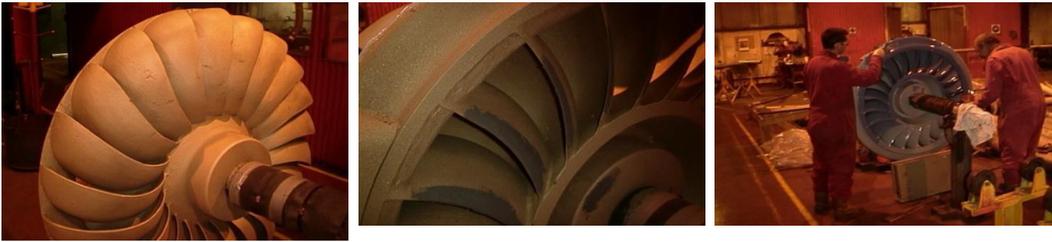
The Turbine Runner was showing signs of erosion on the leading edges of the vanes

- \* 1. Turbine Runner after initial grit blasting ,
- \* 2. Leading edges of vanes rebuilt with Belzona 1311 ,
- \* 3. Application of the 1st coat of Belzona 1341 in progress ,
- \* 4. Completed application of the 2nd coat of Belzona 1341 ,

The surface was properly prepared and the application was carried out in accordance with Belzona Know-How System Leaflets CEP-1 and CEP-3.

Using Belzona allowed the operation to deal with the erosion problems before they became a major problem. Coating the runner with Belzona 1341 will improve its performance and protect it from corrosion in the future.
