BELZONA REPAIRS A LARGE HYDRAULIC RAM

Industry: Oil & Gas
Application: MPT-Mechanical Power Transmission

Customer Location: Offshore oil company - Egypt
Application Date: May 2005

Eight meter hydraulic ram of a transport winch

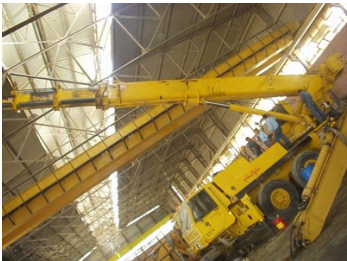
- * General view of the hydraulic ram ,
- * Scores on the ram ,
- * The ram after repair ,
- * Finishing the surface then cleaning it ,

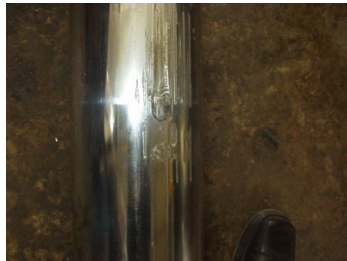
Deep and wide scores in many areas of the ram.

There were scores in many areas of the ram causing many leakages and fluid losses. Belzona saved the replacement costs of the
