BELZONA REPAIRS OFFLOADING HOSE ABOVE WATER

ID: 5585

Customer Location: FPSO, Santos, Brazil
Application Date: April 2015

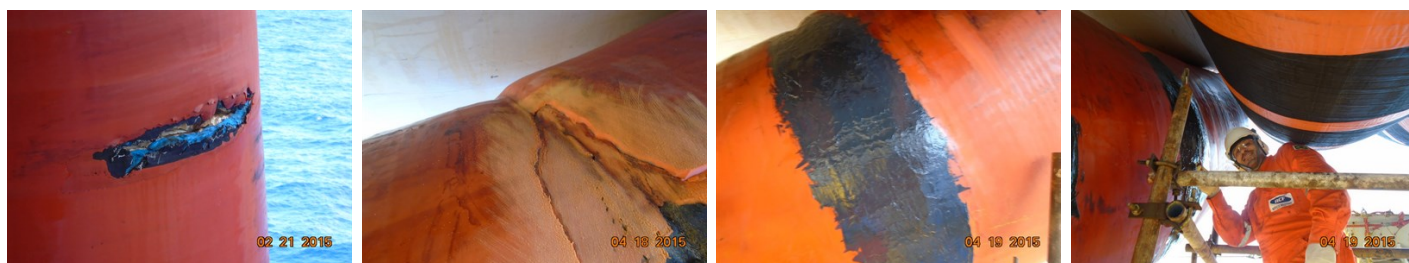
During the normal operation of transfer, staff noticed a small tear in the rubber hose. Three weeks later, the tear had tripled in size and this is when the crew called the experts.

- * View of damaged hose ,
- * Surface preparation ,
- * Completed application ,
- * Overview of the application ,

The application was carried out in accordance with Belzona Know-How System Leaflet SOS-12. The surface was roughened before the application of Belzona 2911 followed by the reinforced system of Belzona 2211 to the damaged areas.
