# BELZONA KEEPS WATER OUT AND THE ENVIRONMENT SAFE

ID: 5586

Industry: Oil & Gas  
Application: SOS-Ships and Offshore Structures

Customer Location: FPSO, Brazil  
Application Date: April 2015

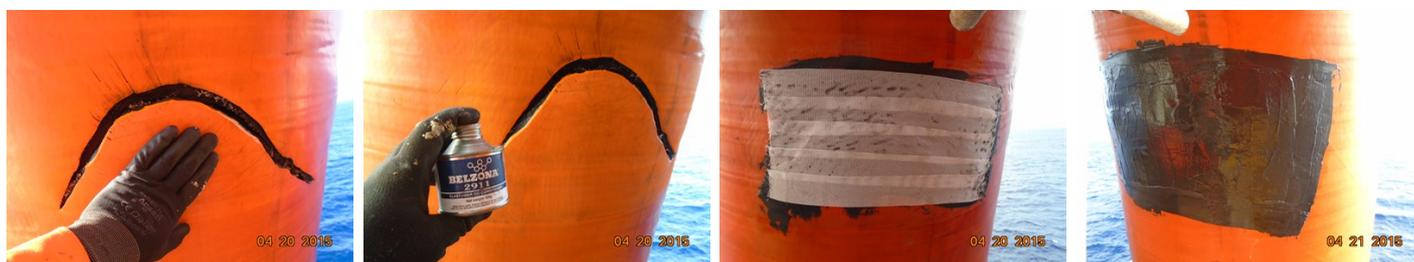
The crew noticed a tear in the rubber of the off loading hose and took the quick decision to call in the experts to repair it with Belzona.

- \* Damaged area ,
- \* Belzona 2911 ,
- \* Reinforcement sheet ,
- \* Completed application ,

Off loading hose damage.

The application was carried out in accordance with Belzona Know-How System Leaflet SOS-12. The surface was roughened before the application of Belzona 2911, followed by the reinforced system of Belzona 2211 to the damaged areas.

The quick decision to make the repair with Belzona prevented the seawater to continue into the inside of the hose, which could lead to the disruption of the hose and oil leak. The repair was made in just four hours.
