BELZONA REPAIRS PVC PUMP

ID: 559

Industry: *General Industry*
Application: *CEP-Centrifugal Pumps*
Substrate: *PVC*
Products: ** Belzona® 1111 (Super Metal) ,*

Customer Location: *Construction company - Egypt*
Application Date: *September 2003*

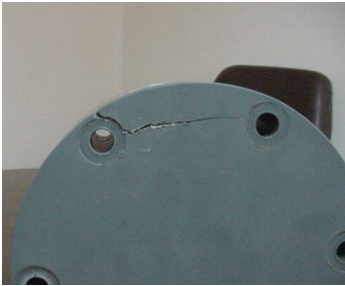
Cracked casing

- * The crack in the PVC pump ,
- * Stabilising the crack ,
- * Cracks after preparation ,
- * Cracks repaired ,

Application was carried out in accordance with a modified version of Belzona Know-How System leaflet CEP-6. The cracks were stabilized by drilling and widening it then filled with Belzona® 1111.
