BELZONA REPAIRS PVC PUMP

ID: 559

Cracked casing

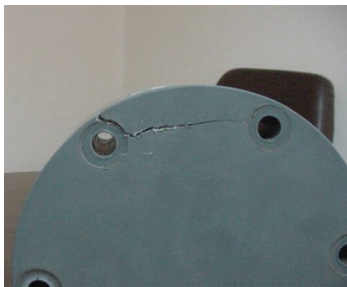
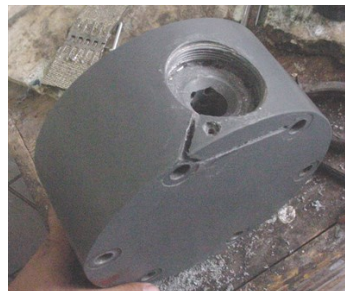
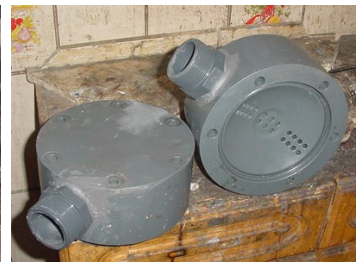
- * The crack in the PVC pump ,
- * Stabilising the crack ,
- * Cracks after preparation ,
- * Cracks repaired ,

Application was carried out in accordance with a modified version of Belzona Know-How System leaflet CEP-6. The cracks were stabilized by drilling and widening it then filled with Belzona® 1111.
