# BELZONA REPAIRS PVC PUMP

Industry: *General Industry*  
Application: *CEP-Centrifugal Pumps*  
Substrate: *PVC*  
Products: *\* Belzona® 1111 (Super Metal) ,*

Customer Location: *Construction company - Egypt*  
Application Date: *September 2003*

*Cracked casing*

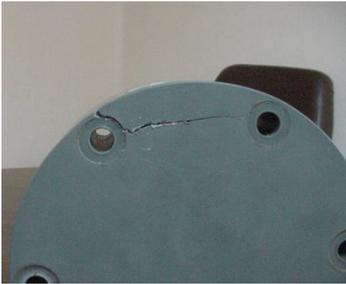
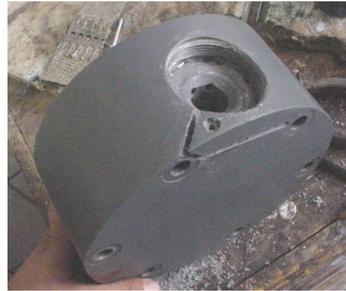
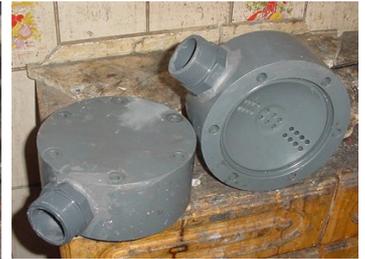
- \* The crack in the PVC pump ,
- \* Stabilising the crack ,
- \* Cracks after preparation ,
- \* Cracks repaired ,

Application was carried out in accordance with a modified version of Belzona Know-How System leaflet CEP-6. The cracks were stabilized by drilling and widening it then filled with Belzona® 1111.
