BELZONA SEALS OIL AND GAS LEAK IN A TRANSFORMER

ID: 5598

Customer Location: Electricity Substation, USA
Application Date: 1997

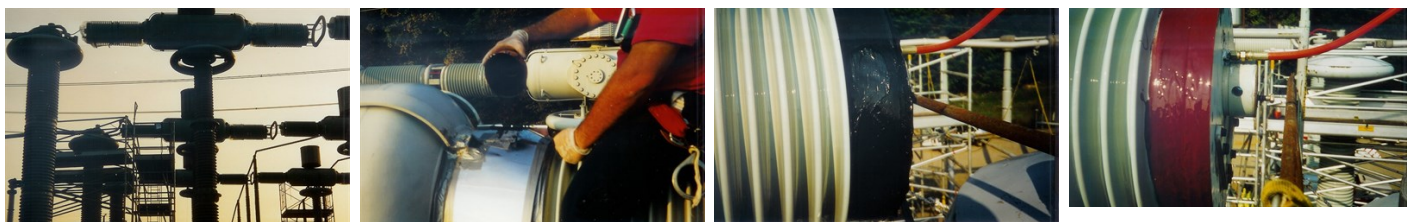
The bushing was leaking oil and gas, creating an environmental hazard and affecting the proper operation of the transformer.

- * Substation overview ,
- * Application under progress ,
- * Sealed area ,
- * Completed application ,

The application was carried out in accordance with a modified version of Belzona Know-How System Leaflet VPF-11. The area was properly prepared and sealed with Belzona 2111 and coated with Belzona 2121.
