# BELZONA REPAIRS TURBINE WICKET GATES

ID: 5599

Customer Location: Hydropower Plant, USA  
Application Date: 1998

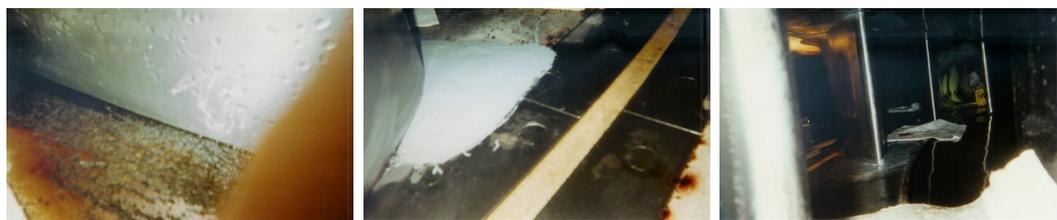
The wicket gates were suffering from cavitation damage due to the water flow. This unit has 1,000,000 gallons of water per minute running through it.

- \* Cavitation damage to the wicket gate ,
- \* Close up of the repaired area with no more cavitation ,
- \* Completed application ,

The application was carried out in accordance with a modified version of Belzona Know-How System Leaflet CEP-5.

The hydropower plant saved time and money by repairing the wicket gates in situ instead of removing them from the plant to be repaired.
