BELZONA REPAIRS TRANSFORMER COOLER

ID: 5601

Customer Location: Electricity Substation, USA
Application Date: 2009

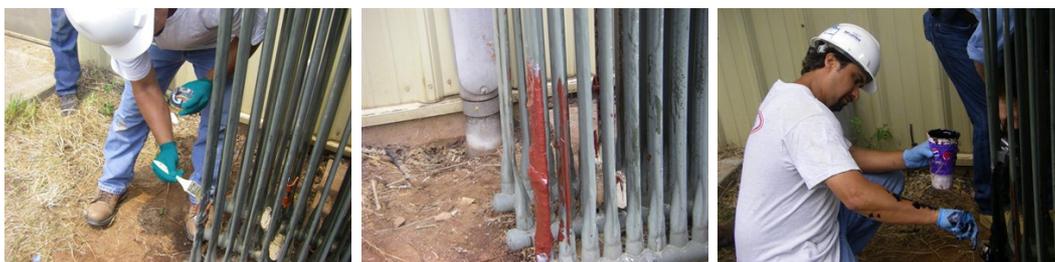
Photograph Descriptions

The cooler on this transformer had a tree growing through it; the customer cut it down with a chainsaw. In the process, they cut the cooler with the chainsaw as well.

- * Preparing the surface ,
- * Belzona 2121 (red) applied over the reinforcement tape ,
- * Finalizing the repair with Belzona 2121 (black) ,

The application was carried out in accordance with a modified version of Belzona Know-How System Leaflet VPF-11. The leaks were repaired with Belzona 2121 and reinforcement tape, similar to a pipe repair.
