BELZONA RAM REPAIR = BIG SAVINGS

ID: 5603

Industry: *General Industry*
Application: *MPT-Mechanical Power Transmission*

Problem

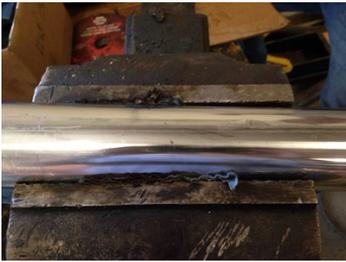
- * Damage to the ram ,
- * Cleaning up the edges with a Dremel ,
- * Belzona 1111 post application/waiting to cure ,
- * Completed application to ram and ready for service ,

Hydraulic ram suffering scars in 3 places from being repeatedly struck against the side of a dumpster. Customer was looking for an alternative to replacing the expensive ram.
