UPGRADED BELZONA LINING SPECIFICATION FOR SEA WATER PUMP

ID: 5604

Customer Location: Power Plant, Taiwan
Application Date: October 2014

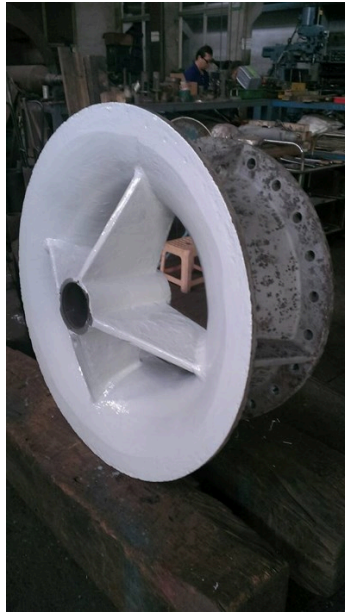
Superior erosion resistant lining required to protect the pump from further erosion-corrosion.

- * Completed application on impeller ,
- * Completed application on casing ,
- * Completed application on casing ,
- * View of completed application on cooling water pump ,

The application was carried out in accordance with Belzona Know-How System Leaflet CEP-3.

Belzona 1321 had been previously applied in their sea water cooling pumps with excellent performance. After introducing Belzona 1331 as a better erosion resistant coating than Belzona 1321 but also more user friendly than Belzona 1321, the customer switched to Belzona 1331 for lining their pumps. The application contractor used Belzona 1321 for years and after the application of Belzona 1331, commented that the new system is more user friendly and easier to apply.
