BELZONA KEEPS RIG RUNNING AFTER GLASS FLAKE FAILURE

ID: 5606

Customer Location: North Sea, UK
Application Date: May 2015

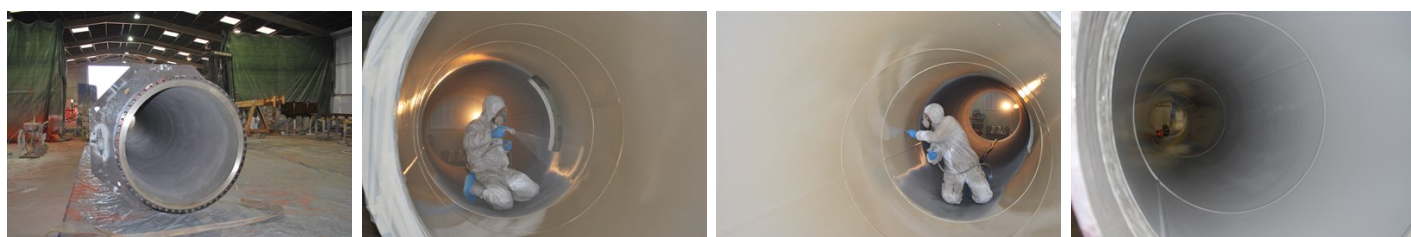
Photograph Descriptions

Existing caisson had been lined with a glass flake coating, which has since failed. HSE authority have requested for the caisson to be replaced or the rig would have to be shut down. Given the short notice, metal cladding of the caisson was no longer an option. Additionally, the customer would not repeat the same mistake by specifying a glass flake coating again. A key parameter in the material selection was the design life of 35 years. The lining option would have to be robust and remain maintenance-free for a long time.

- * Grit blasted caisson ,
- * Spray application in progress ,
- * Lining thickness being measured ,
- * Completed application ,

A 52" diameter seawater discharge caisson made up of 5 sections of varying lengths (between 11 and 15 meters) on an offshore oil rig required internal corrosion protection.

The application was carried out in accordance with Belzona Know-How System Leaflet VPF-2. The coating was applied at a thickness of 2 x 1000 microns to optimize longevity of the equipment. Flange faces were protected with Belzona 1111.
