# Valve Repair and Protection with Belzona

Customer Location: Power plant, Egypt

Application: VPF-Valves, Pipes and Fittings

Automatic chemicals valve.

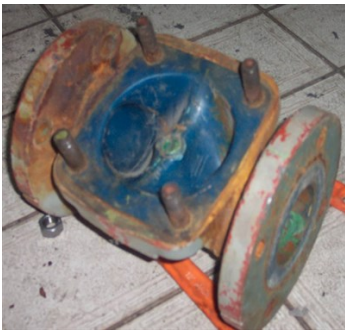
Old polypropylene lining was worn and damaged due to chemical attack.

- \* The valve before repair ,
- \* Former made by casting with Belzona® 5811 ,
- \* Belzona® 1311 applied to the valve ,
- \* Two valves were repaired and protected ,

Application was carried out in accordance with modified version of Belzona Know-How system leaflet VPF-1 and VPF-2. A former was made by casting Belzona<sup>®</sup> 5811 to take the inner shape of the valve. The eroded areas were then rebuilt with Belzona 1311,
