# Valve Repair and Protection with Belzona

ID: 561

Customer Location: Power plant, Egypt

Application: VPF-Valves, Pipes and Fittings

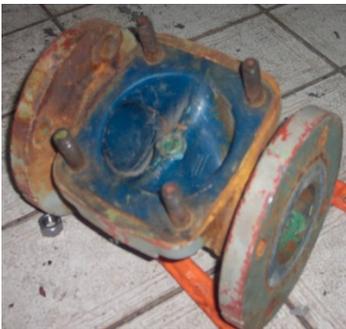
Old polypropylene lining was worn and damaged due to chemical attack.

- \* The valve before repair ,
- \* Former made by casting with Belzona® 5811 ,
- \* Belzona® 1311 applied to the valve ,
- \* Two valves were repaired and protected ,

Application was carried out in accordance with modified version of Belzona Know-How system leaflet VPF-1 and VPF-2. A former was made by casting Belzona® 5811 to take the inner shape of the valve. The eroded areas were then rebuilt with Belzona 1311,

using the Belzona® 5811 former to restore the inner curvature profile of the valve. After finishing the surface it was coated with Belzona® 1321 to protect the valve.
