# BELZONA REPAIRS AND PROTECTS TURBINE ROTOR

ID: 5615

**Customer Location:** Hydroelectric Power Plant, Brazil  
**Application Date:** September 2011

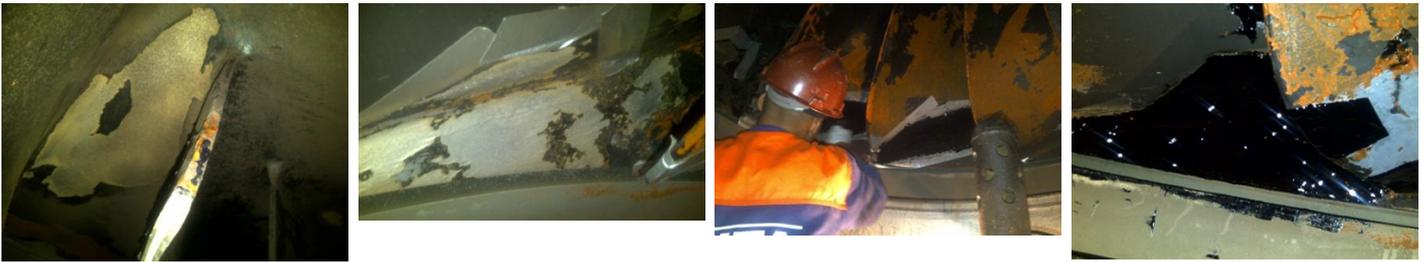
Wear caused by the effects of erosion and cavitation to the rotor with a waterfall height of 110 meters.

- \* Worn area of the rotor ,
- \* Defining the application area ,
- \* Application under progress ,
- \* Completed application ,

The application was carried out in accordance with Belzona Know-How System Leaflet CEP-1. The surface was prepared according to the standard NACE 2 (equivalent to SA 2 ½) with dry abrasive blast to near white metal. Belzona 1311 was applied to smooth the wear on the vanes (holes and loss of thickness) and then, Belzona 2141 was partially applied in certain areas of the rotor. Subsequently, Belzona 2141 was applied in 2 coats.
