BELZONA SEALS LEAK IN BUTTERFLY VALVE

Industry: Power

Application: VPF-Valves, Pipes and Fittings

Customer Location: Electric Energy Company, Brazil

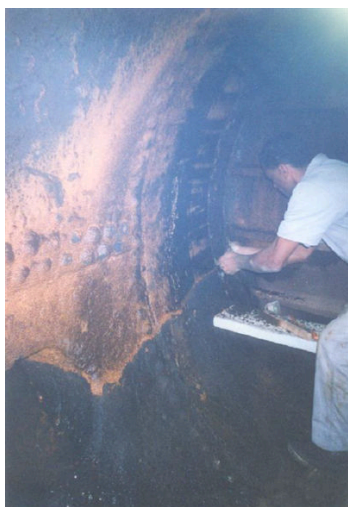
The valve presented excessive leaking, compromising the seal of the fluid and the interior of the pipe.

- * Cleaning the surface ,
- * Application of Belzona 1221 to the leak area ,
- * Application of Belzona 1111 in progress ,
- * Completed application ,

First, the water flow was diverted to allow the application. The application was carried out in accordance with Belzona Know-How System Leaflet VPF-1. The surface was prepared with a grinder, emery cloth and wire brush. The valve was locked and Belzona 1221 was applied to stop the leak. After Belzona 1221 cured, Belzona 1111 was applied.
