BELZONA REPAIRS AND COATS HYDROELECTRIC TURBINE PIPELINES AND VANES

ID: 5618

Customer Location: *Hydroelectric Power Plant, Brazil*
Application Date: *November 2008*

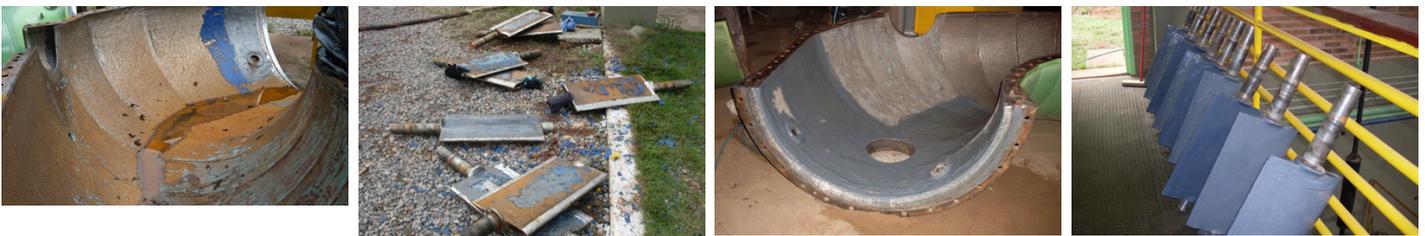
Photograph Descriptions

Wear caused by erosion and corrosion in the areas with high water turbulence.

- * Internal surface of the damaged pipeline ,
- * Damaged vanes ,
- * Lower area of the pipeline coated with Belzona 1321 ,
- * Vanes protected with Belzona 1321 ,

The application was carried out in accordance with Belzona Know-How System Leaflet CEP-1. The surface was prepared with a dry abrasive blast and cleaned with a degreaser. The worn areas were repaired with Belzona 1311 and then coated with Belzona 1321 to protect against erosion and corrosion.
