BELZONA RECOVERS ELECTRIC ENERGY TRANSMISSION TOWER BASE

ID: 5620

Customer Location: Electric Energy Company, Brazil
Application Date: October 2008

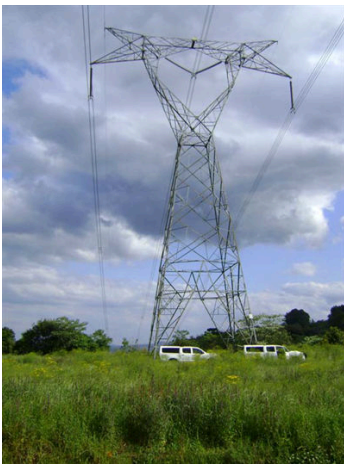
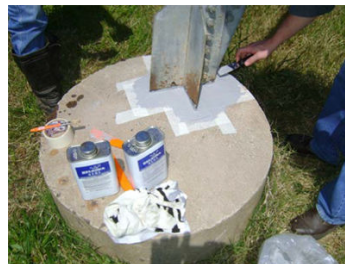
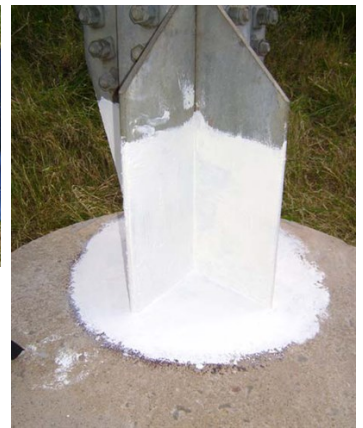
Photograph Descriptions

Due to the transmission towers being exposed to weathering, its concrete bases suffer from deterioration. The accumulated rainwater tends to oxidize the structure of the tower, weakening the metal base.

- * View of the transmission tower ,
- * Deteriorated base ,
- * Application of Belzona 4111 ,
- * Waterproofed base with Belzona 3111 ,

Concrete base of the leg of the transmission tower.

The application was carried out in accordance with Belzona Know-How System Leaflet GSS-3. Firstly, the concrete surface was abraded, cleaned and allowed to dry. The conditioner, Belzona 4911, was applied and allowed to dry. Belzona 4111 was then applied. After the completed cure time and dry to the touch of Belzona 4111, Belzona 3921 was applied and after the specific

amount of time, Belzona 3111 was applied.

Belzona offered the customer an excellent cost effective solution, recovering and waterproofing the area susceptible to water accumulation.
