BELZONA RECOVERS ELECTRIC ENERGY TRANSMISSION TOWER BASE

ID: 5620

Customer Location: Electric Energy Company, Brazil
Application Date: October 2008

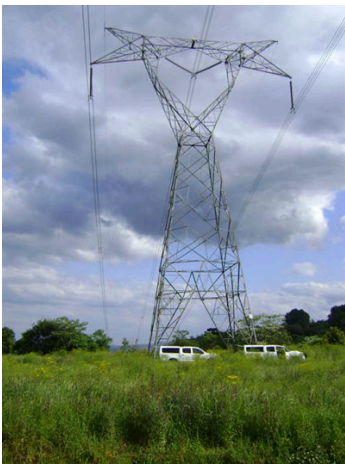
Due to the transmission towers being exposed to weathering, its concrete bases suffer from deterioration. The accumulated rainwater tends to oxidize the structure of the tower, weakening the metal base.

- * View of the transmission tower ,
- * Deteriorated base ,
- * Application of Belzona 4111 ,
- * Waterproofed base with Belzona 3111 ,
