BELZONA RECOVERS ELECTRIC ENERGY TRANSMISSION TOWER BASE

ID: 5620

Customer Location: Electric Energy Company, Brazil
Application Date: October 2008

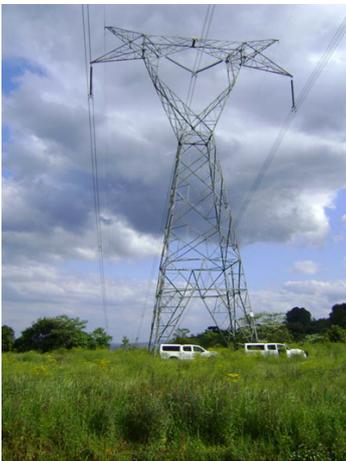
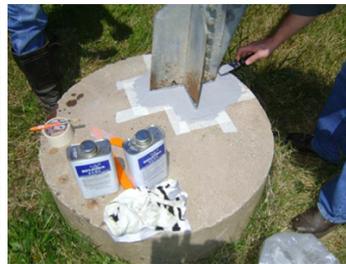
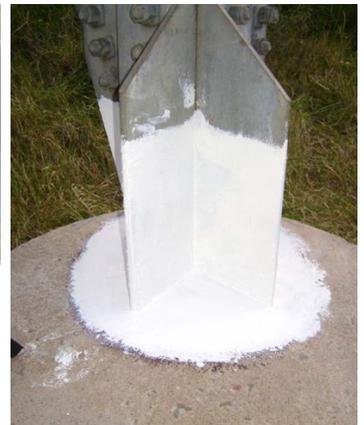
Photograph Descriptions

Due to the transmission towers being exposed to weathering, its concrete bases suffer from deterioration. The accumulated rainwater tends to oxidize the structure of the tower, weakening the metal base.

- * View of the transmission tower ,
- * Deteriorated base ,
- * Application of Belzona 4111 ,
- * Waterproofed base with Belzona 3111 ,

The application was carried out in accordance with Belzona Know-How System Leaflet GSS-3. Firstly, the concrete surface was abraded, cleaned and allowed to dry. The conditioner, Belzona 4911, was applied and allowed to dry. Belzona 4111 was then applied. After the completed cure time and dry to the touch of Belzona 4111, Belzona 3921 was applied and after the specific

amount of time, Belzona 3111 was applied.
