BELZONA SEALS TRANSFORMER OIL STORAGE TANKS

ID: 5622

Industry: Chemical & Petrochemical
Application: TCC-Tanks and Chemical Containment Areas

Customer Location: Oil supplier, UK
Application Date: June 2015

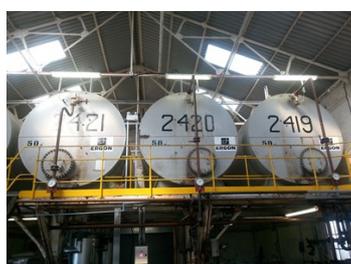
- * Transformer oil storage tanks ,
- * Leaking weld ,
- * Completed application with protective coating on top ,
- * Additional repair area ,

Transformer oil storage tanks. The client recycles millions of liters of transformer oil every year. As part of the process, they extract the moisture from recycled oil by shutting the tanks off from the atmosphere and connecting the tanks to silica gel tanks to remove the moisture.

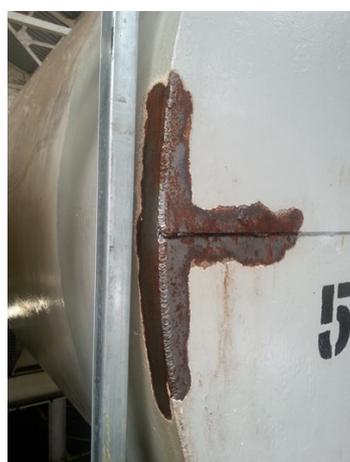
On inspection of the tanks, leaks were evident at the seams. Welding was considered for the repairs, however, due to the area being classed as a confined space and the requirement to take the tanks offline, this was not a desirable option.

Belzona 1212 was used to bond pre-manufactured plates onto the damaged areas of the tanks. Once cured, Belzona 5831 was applied to the plated area to provide long term environmental protection. This application was completed on 6 areas where leaks were identified.
