BELZONA PLATE BONDING REPAIRS TO REACTION TANK

ID: 5624

Application: TCC-Tanks and Chemical Containment Areas

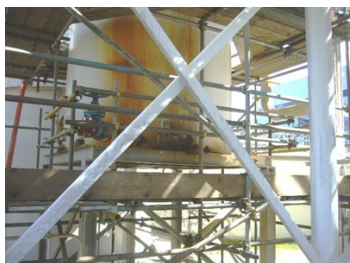
- * Tank with scaffold erected ,
- * Thin wall area ,
- * & 4. Plate bonded and overcoated ,

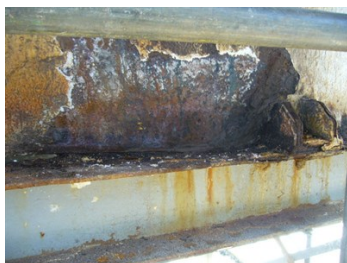
Tank experiencing external corrosion due to rainwater sitting around the lower edges of the outer wall. The external paint system had failed and the tank was going thin wall in places.
