BELZONA REPAIRS AND PROTECTS TURBINE

Customer Location: Hydroelectric Plant, Honduras

Application Date: December 2004

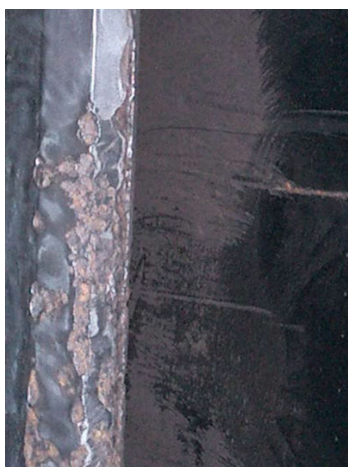
Damage on the 24 turbine blades due to erosion and corrosion. 70% of the blades had the same type of problem.

- * Damage on the turbine blades ,
- * Application of Belzona 1111 ,
- * Application of Belzona 1321 ,
- * Blades rebuilt and protected ,
