# BELZONA REPAIRS AND PROTECTS TURBINE

ID: 5639

Customer Location: Hydroelectric Plant, Honduras  
Application Date: December 2004

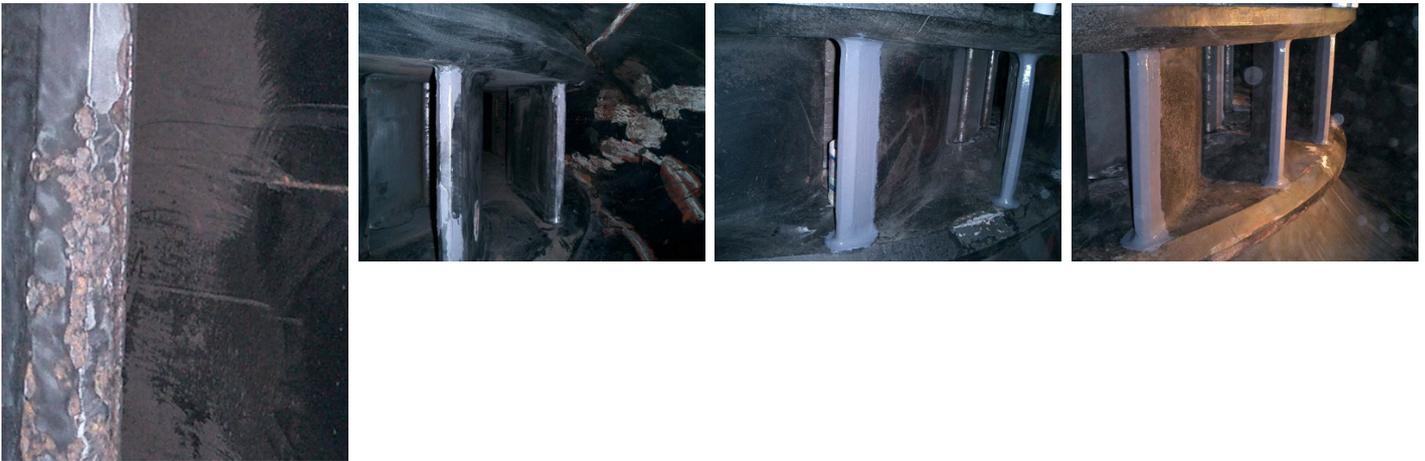
Damage on the 24 turbine blades due to erosion and corrosion. 70% of the blades had the same type of problem.

- \* Damage on the turbine blades ,
- \* Application of Belzona 1111 ,
- \* Application of Belzona 1321 ,
- \* Blades rebuilt and protected ,

The surface preparation was carried out with mechanical tools, such as grinder, until the area was rough, clean and free from contamination. Belzona 9111 was applied to clean and decontaminate the area. The application was carried out in accordance with Belzona Know-How System Leaflet CEP-1. The application of Belzona 1111 was carried out in 2 hours on 24 blades. After the product cured, it was machined to give the final profiles to the blades. To protect the repair, Belzona 1321 was applied with a brush

in a layer of 500 microns.
