BELZONA REPAIRS TO VACUUM STEAM JET EJECTOR - 3 YEARS AND STILL GOING STRONG

ID: 564

Customer Location: *Chemical Plant - Northern Italy*
Application Date: *July 2002*

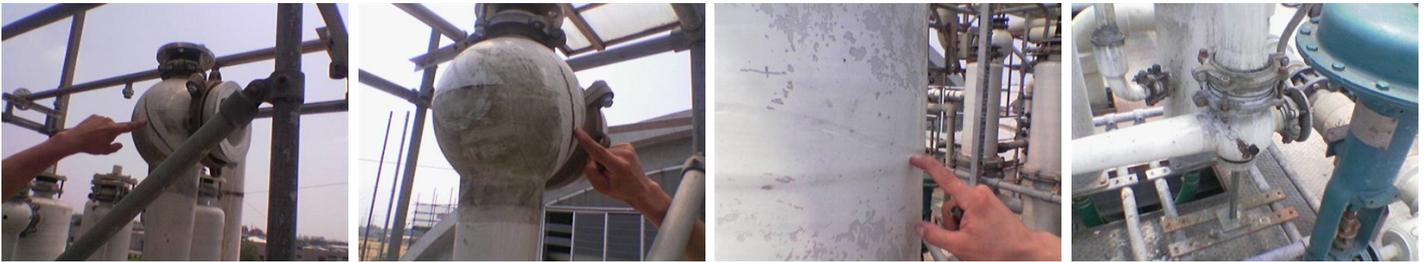
Photograph Descriptions

The steam jet ejector was fragmented into many parts and a replacement was not immediately available.

- * View of the first repair where Belzona® 1391 was used ,
- * Damage to the bowl is clearly evident ,
- * & 4. Other similar equipment which has been repaired ,

Application was carried out in accordance with Belzona Know-How System Leaflet PDP-1.

Application has been in service 24 hours a day for three years. Belzona® 1391 was chosen due to the temperature which could from time to time, go higher. Other steam jet ejectors have been repaired at this facility with Belzona® 4301 (Magma CR1 Hi-Build) with the same excellent results. The replacement - ordered some three years ago - remains in stock.
