BELZONA KEEPS WIND TURBINES SPINNING

ID: 5642

Customer Location: Wind Farm, Teesside, UK
Application Date: September, 2014

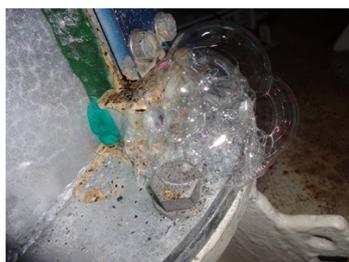
Many of the flanges were not gas tight. Changes in tide led to dangerous gases seeping from the seabed and into the chamber. A temporary sealant had been applied but could not effectively seal the leaks and a permanent solution was required.

- * View of the wind farm ,
- * Leaking flange ,
- * Second leaking flange ,
- * Belzona solution applied ,

Belzona, Belzona's UK application division, was signed on to carry out the repairs with the application in accordance with Belzona Know-How System Leaflet VPF-11. After removing the temporary repairs and preparing the surfaces, Belzona 1161 was used to pack the joint and seal the nuts and bolts using caps filled with product. Two coats of Belzona 5831 were applied onto the flange tops and bottoms to ensure a lasting protection and to eliminate any risk of leaks.
