BELZONA KEEPS WIND TURBINES SPINNING

Customer Location: Wind Farm, Teesside, UK
Application Date: September, 2014

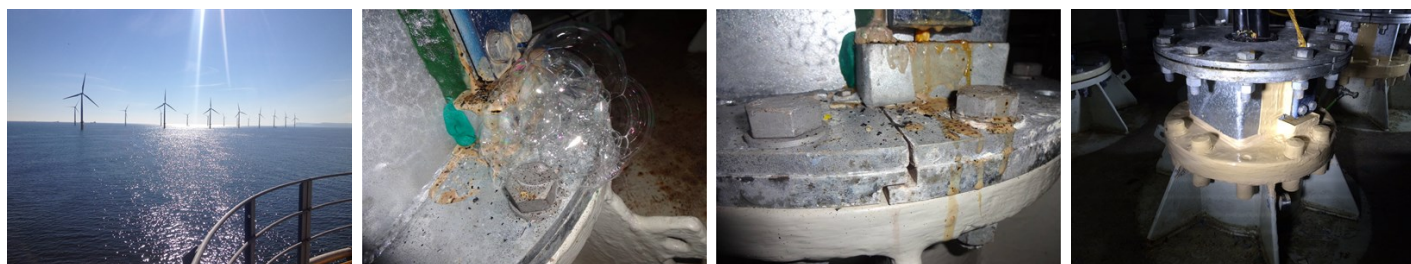
Many of the flanges were not gas tight. Changes in tide led to dangerous gases seeping from the seabed and into the chamber. A temporary sealant had been applied but could not effectively seal the leaks and a permanent solution was required.

- * View of the wind farm ,
- * Leaking flange ,
- * Second leaking flange ,
- * Belzona solution applied ,

Belzona, Belzona's UK application division, was signed on to carry out the repairs with the application in accordance with Belzona Know-How System Leaflet VPF-11. After removing the temporary repairs and preparing the surfaces, Belzona 1161 was used to pack the joint and seal the nuts and bolts using caps filled with product. Two coats of Belzona 5831 were applied onto the flange tops and bottoms to ensure a lasting protection and to eliminate any risk of leaks.

surface-tolerant leak sealing system. After more than a year in service, the repair is performing well with no reported leaks or damage to the flanges. The use of a surface-tolerant composite and coating ensured that the repair could be carried out quickly regardless of surface moisture or contamination as these materials bond exceptionally well to oily or greasy surfaces and even underwater.
