BELZONA NEW GENERATION HIGH TEMPERATURE LINING PROTECTS DESULFURIZATION UNIT

Customer Location: Natural Gas Purification Plant, South East of China

Application: TCC-Tanks and Chemical Containment Areas

Reboiler in the Desulfurization unit.

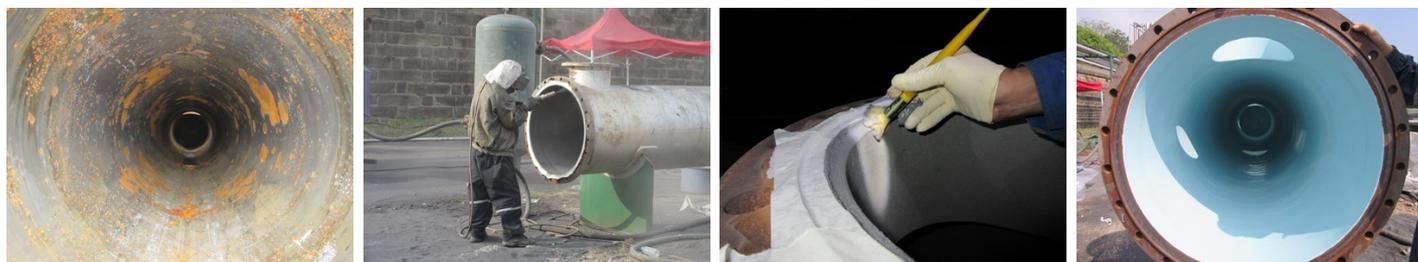
Photograph Descriptions

The vessel operates at 150°C (302°F) and 1.6 MPa (232 psi) pressure. The amine media, rich in H₂S, is extremely corrosive, leading to severe pitting and thinning of the vessel wall, thereby increasing operational risks.

- * Interior of the vessel before surface preparation ,
- * Surface preparation by grit blasting under way ,
- * Rebuilding pitted areas with Belzona 1511 ,
- * Finished application with 2 coats of Belzona 1593 after inspection ,

The application was carried out in accordance with Belzona Know-How System Leaflet TCC-5. Belzona 1511 was used to fill the pitted areas and two (2) coats of Belzona 1593 were applied for overall corrosion protection.

The life of this piece of equipment was extended at a fraction of the cost of replacement. More importantly, the excellent corrosion protection provided by Belzona 1593 will ensure that the vessel operates safely.
