BELZONA NEW GENERATION HIGH TEMPERATURE LINING PROTECTS DESULFURIZATION UNIT

Customer Location: Natural Gas Purification Plant, South East of China

Application: TCC-Tanks and Chemical Containment Areas

Reboiler in the Desulfurization unit.

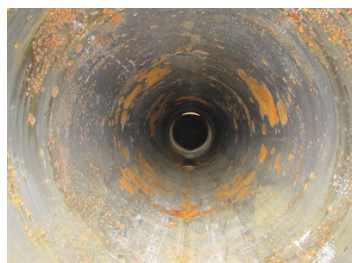
The vessel operates at 150°C (302°F) and 1.6 MPa (232 psi) pressure. The amine media, rich in H₂S, is extremely corrosive, leading to severe pitting and thinning of the vessel wall, thereby increasing operational risks.

- * Interior of the vessel before surface preparation ,
- * Surface preparation by grit blasting under way ,
- * Rebuilding pitted areas with Belzona 1511 ,
- * Finished application with 2 coats of Belzona 1593 after inspection ,
