# No Job is Too Small for Belzona

ID: 565

Application: *ENC-Engines and Casings*

Yamaha YZ 250 cc - 2001

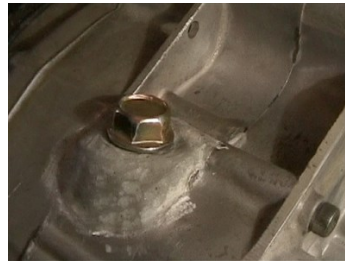
- \* Yamaha YZ 250 ,
- \* Broken thread ,
- \* Completed work ,
- \* See the rebuilt fillet ,

Still in service after months of intensive use.

Application was carried out in accordance with Belzona Know-How System Leaflet ENC-2. The area was post-cured at 50° C for five hours to ensure that the oil seals were not damaged.
