No Job is Too Small for Belzona

ID: 565

Application: *ENC-Engines and Casings*

Yamaha YZ 250 cc - 2001

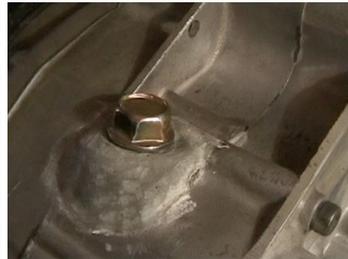
Activities during a motocross race caused a stripped thread. Piece of equipment quite expensive.

- * Yamaha YZ 250 ,
- * Broken thread ,
- * Completed work ,
- * See the rebuilt fillet ,

Application was carried out in accordance with Belzona Know-How System Leaflet ENC-2. The area was post-cured at 50° C for five hours to ensure that the oil seals were not damaged.
