# BELZONA 1111 FIXES THE FIBERGLASS FLANGE

Industry: Marine  
Application: VPF-Valves, Pipes and Fittings  
Substrate: Fiberglass  
Products: \* Belzona 1111 (Super Metal) ,

Customer Location: Marine Industry, S.W. Washington  
Application Date: May 2015

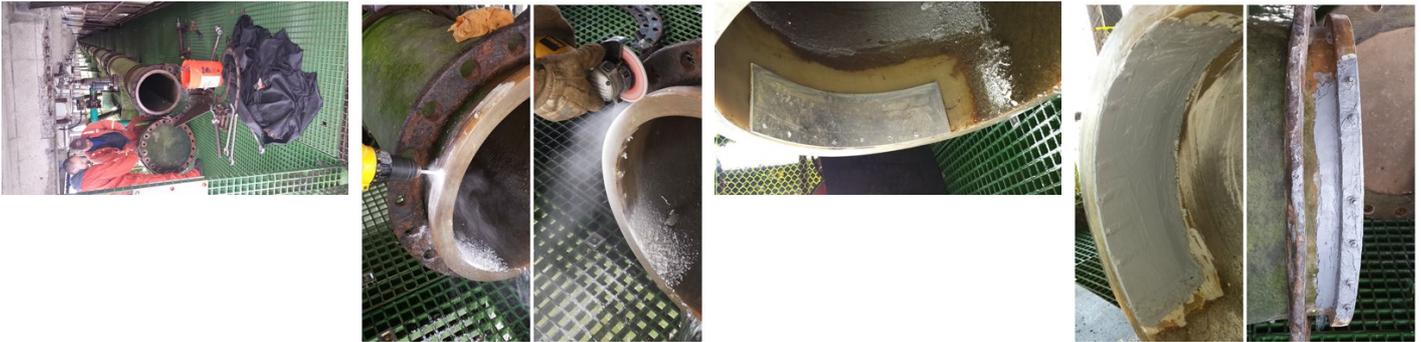
Cracks appearing in the flange and leaking water when the system was pressurized.

- \* Preparing the area to expose the crack ,
- \* Drilling and V'ing the crack ,
- \* Steel plate fitted and drilled ,
- \* Completed application, inside and outside ,

The application was carried out in accordance with Belzona Know-How System Leaflet VPF-9. The ends of the cracks were located and drilled through to terminate the crack. The cracks were worse than originally thought, actually cracking into three different areas. The cracks were then drilled every 1" and V'd out. A thin, mild steel plate was fit to the inside of the pipe with holes drilled in it as well matching the pipe. Both the steel plate and fiberglass pipe were prepped by grinding where Belzona 1111 was to be applied. Belzona 1111 was mixed and applied to the fiberglass pipe, carefully pushing it into the crack and holes. The steel plate was mounted inside the pipe and mounted with bolts and then covered with a thin layer of Belzona 1111. The exterior portion of the crack was smoothed over to allow the metal collar to still fit on the flange.
