BELZONA REPLACES PTFE LINING AND CUTS DOWNTIME

ID: 5655

Industry: Chemical & Petrochemical
 Application: TCC-Tanks and Chemical Containment Areas
 Substrate: Steel
 Products: * Belzona 1593 ,

Customer Location: Chemical Plant, Ferrara, Italy
 Application Date: April, 2015

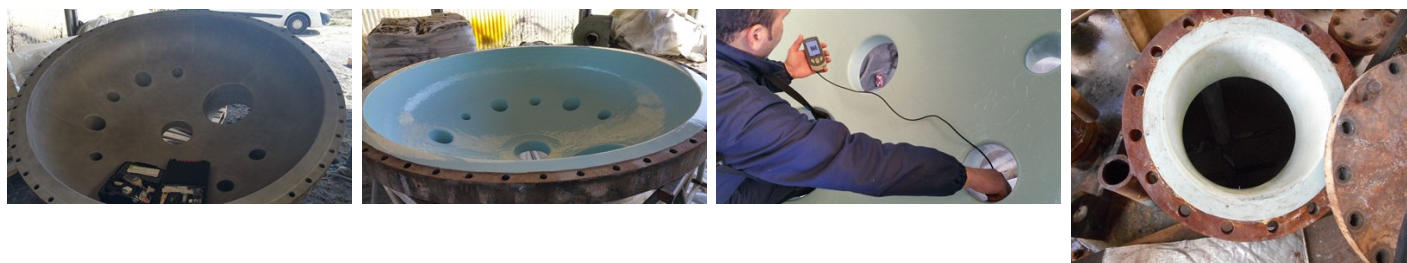
Photograph Descriptions

The original hot applied PTFE Lining required maintenance due to localised disbondment. The plant was facing a long downtime as it was not possible to conduct an in-situ repair of such a lining. The customer was looking for a solution that was faster and easier to apply.

- * PTFE lining removed ,
- * Belzona lining applied ,
- * Coating thickness measured ,
- * Inspected after 6 months in service ,

The application was carried out in accordance with Belzona Know-How System Leaflet TCC-5 for protecting and rebuilding steelwork. After grit blasting to SA 2.5, a two-coat system of Belzona 1593 was hand applied to an area of 25 m².
