FIRE TRUCK PUMP GETS NEW LIFE WITH BELZONA

ID: 5660

Customer Location: *Fire Department, Texas, USA*
Application Date: *2013*

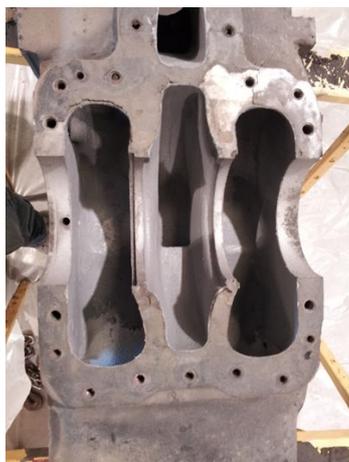
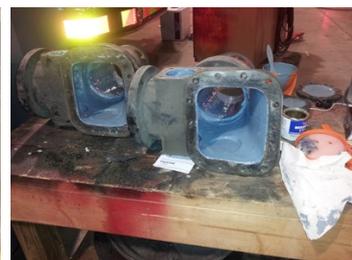
The pump had suffered severe corrosion due to intermittent use.

- * View of the fire truck ,
- * Blasted pump ,
- * Coated pump ,
- * Coated valve body ,

The application was carried out in accordance with Belzona Know-How System Leaflets CEP-1 and CEP-3. Pump was blasted and repaired with Belzona 1111 prior to being coated with Belzona 1341.
