BELZONA REPAIRS A BULLET HOLE ON A MEMORIAL

ID: 5661

City park memorial statue.

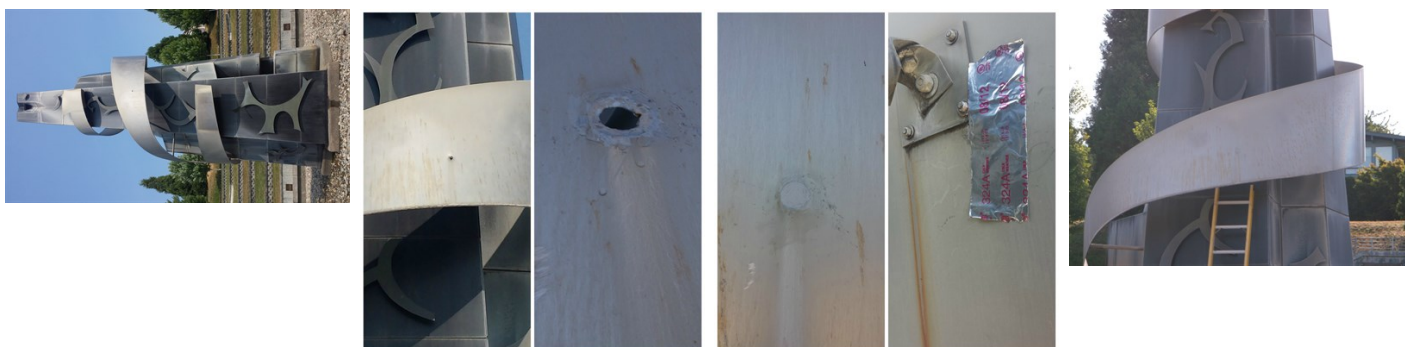
Photograph Descriptions

Someone had fired a bullet at the statue. The bullet struck the metal band from behind resulting in a mushrooming effect out of the face. This statue has water running over the front of it and because of the metal being pushed out from the bullet it was beginning to streak and stain causing discoloration of the metal.

- * The statue with the bullet hole visible. ,
- * The bullet hole up close / The bullet hole prepped. ,
- * The completed repair. Front / Back. ,
- * The repair from 40' away, virtually invisible. ,

The damaged metal was ground down leaving a rough and slightly concave area. The Belzona 4111 resins were mixed and used to condition the surface. The Belzona 4111 aggregate was then added to the resins until it was of a thick and "dry" consistency. A piece of tape was mounted to the back after applying a layer of Belzona 4111 to hold the Belzona 4111 in place until it cured. The front surface was then packed full and tight, then the excess was carefully removed, and the remaining Belzona 4111 smoothed off.

6 teaspoons of Belzona 4111 were used for this repair. The alternative was to weld which would result in heat distortion and discoloration. Belzona 4111 was a near perfect match to the color of the metal. The repair of this memorial statue has been on hold for several years because they did not want to further damage the statue by trying to repair it.
