# BELZONA PROTECTS TAIL SHAFT ON A US NAVY SHIP

ID: 5665

Tail Shaft of U.S. Navy Ship.

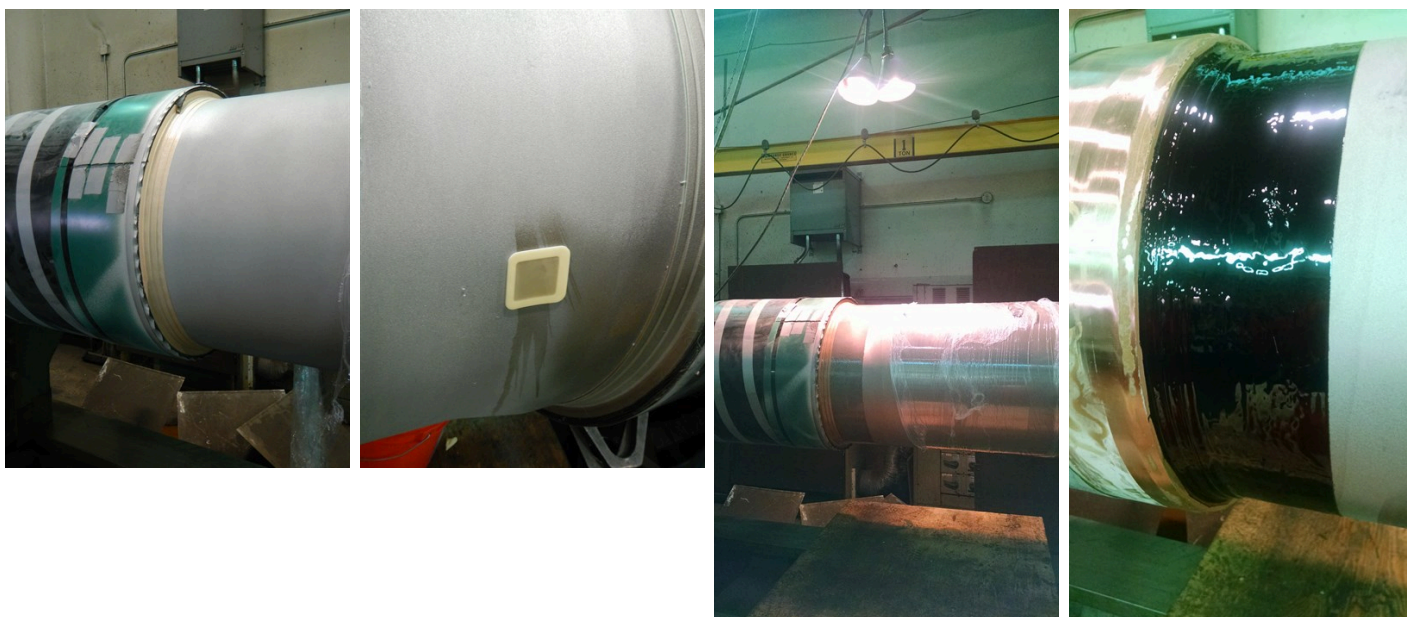
## Photograph Descriptions

*The US Navy required superior protection against erosion and corrosion in the transition area of shaft coatings.*

- \* Tail shaft after grit blasting ,
- \* Chloride test ,
- \* Tail shaft with Belzona 2941 ,
- \* Completed shaft coating ,

The application was carried out in accordance with Belzona Know-How System Leaflet SOS-2. The shaft was grit blasted to an SSPC-SP10 finish and then coated with Belzona 2941. The shaft areas were then coated with Belzona 2141 and finally with a fiberglass coating.

Belzona is expected to last through the 5 year Tail Shaft inspections by the American Bureau of Shipping (ABS).
