BELZONA EMERGENCY LEAK SEALING

ID: 567

Industry: Oil & Gas
Application: HEX-Heat Exchangers
Substrate: Carbon steel
Products: * Belzona® 1321 (Ceramic S-Metal) ,

Customer Location: Oil refinery, Egypt
Application Date: October 2003

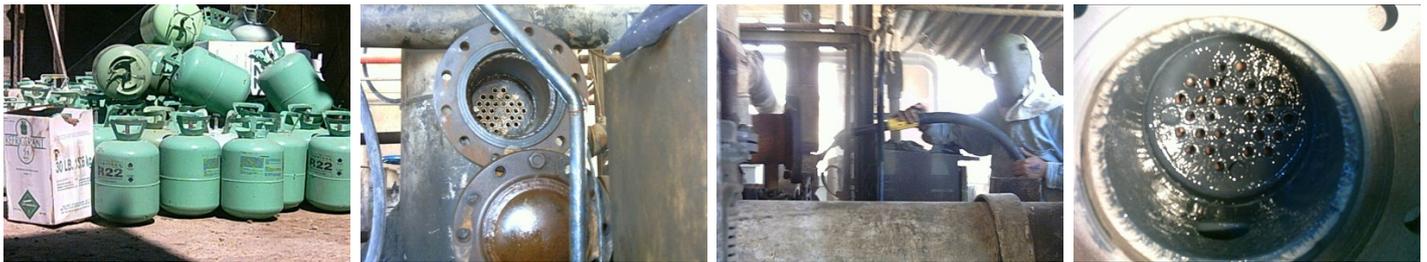
Photograph Descriptions

Bi-metallic corrosion between the tubes and the tube sheet had caused Freon leakage.

- * General view of the consumed Freon containers used to replenish leaks. ,
- * The tube sheet suffering from Freon leakage ,
- * Surface preparation by grit blasting ,
- * Belzona® 1321 applied to stop the leakage ,

Application was carried out in accordance with Belzona Know-How System Leaflet HEX-3.

Beside the health factors, Belzona has saved about \$35,000 annually for refilling Freon due to leakage, only in three hours of work and \$340 for Belzona products. The repair was completed quickly and safely with out heat.
