# BELZONA EMERGENCY LEAK SEALING

Industry: Oil & Gas  
Application: HEX-Heat Exchangers  
Substrate: Carbon steel  
Products: \* Belzona® 1321 (Ceramic S-Metal) ,

Customer Location: Oil refinery, Egypt  
Application Date: October 2003

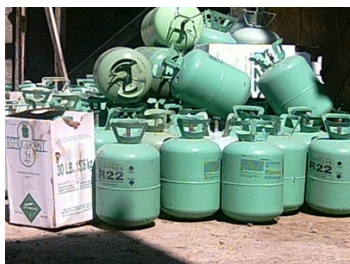
- \* General view of the consumed Freon containers used to replenish leaks. ,
- \* The tube sheet suffering from Freon leakage ,
- \* Surface preparation by grit blasting ,
- \* Belzona® 1321 applied to stop the leakage ,

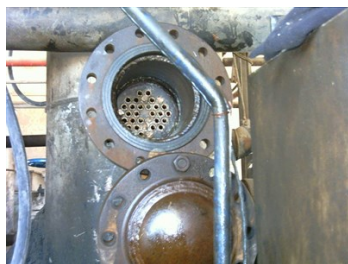
*Bi-metallic corrosion between the tubes and the tube sheet had caused Freon leakage.*
