BELZONA RESCUES A 100-YEAR OLD PENSTOCK

ID: 5672

Customer Location: Hydropower, Northeastern USA
Application Date: 2007

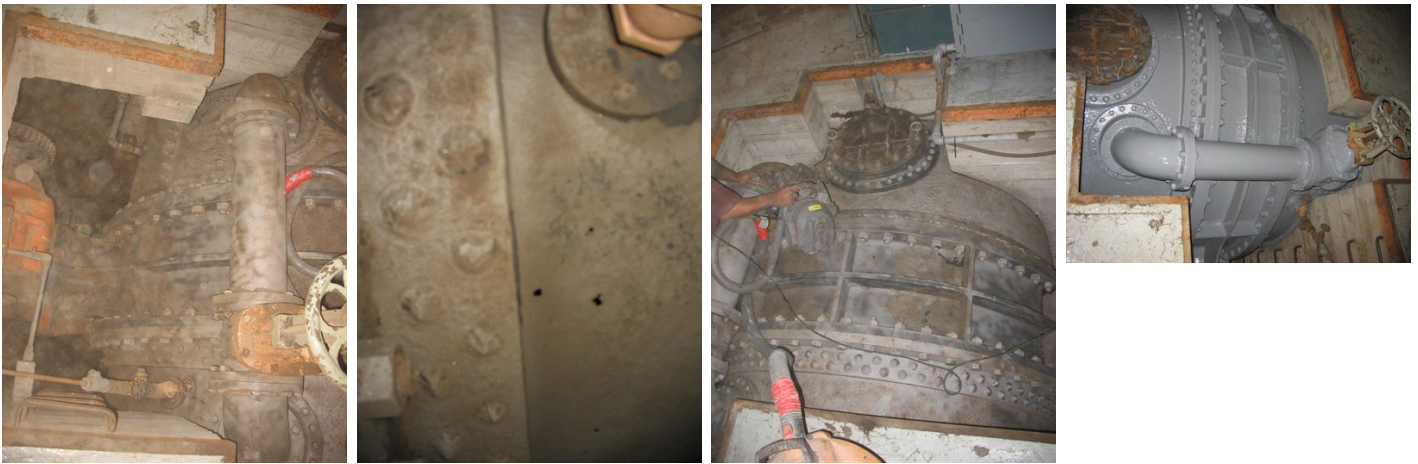
100 plus year old steelwork was corroding from moisture. The problem was detected when installing new control valves and trash racks on penstocks.

- * Penstock embedded in concrete thrust block at base of the dam ,
- * Pinholes discovered during the work ,
- * Surface prepared by blasting ,
- * Completed application ,

The plant was originally built in 1908 and the original steelwork showed significant exterior corrosion, thus operators feared that it would soon have pinholes. The plant was shut down for control upgrades so operators chose Belzona because of its reputation in similar situations.

The surface was properly prepared by abrasive blasting. First, the pits and holes were repaired with Belzona 1121 and then overcoated with Belzona 5811.
