BELZONA REBUILD TRENCH DRAIN AT PAPER MILL

ID: 5684

Industry: *Pulp & Paper*
Application: *FPA-Floor Problem Areas*
Substrate: *Concrete*
Products: ** Belzona 4111 (Magma-Quartz) ,*

Customer Location: *Paper Mill, Northern Texas, USA*
Application Date: *2014*

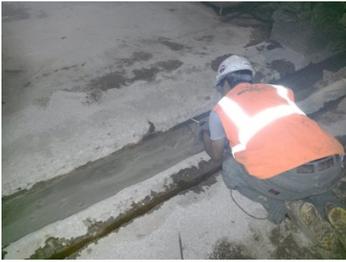
- * Edges being prepared while drain is in use ,
- * Forms used to rebuild edges with Belzona 4111 ,
- * Grate replaced over the trench ,
- * One year later, still performing well ,

The application was carried out in accordance with Belzona Know-How System Leaflet FPA. Loose concrete was chipped away and the edges were ground. A wood former was used to rebuild the edges to the original width and height.
