BELZONA REBUILD TRENCH DRAIN AT PAPER MILL

ID: 5684

Industry: *Pulp & Paper*
Application: *FPA-Floor Problem Areas*
Substrate: *Concrete*
Products: ** Belzona 4111 (Magma-Quartz),*

Customer Location: *Paper Mill, Northern Texas, USA*
Application Date: *2014*

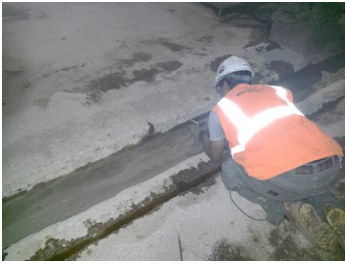
The concrete holding up the grate was so damaged that the grate fell into the trench.

- * Edges being prepared while drain is in use ,
- * Forms used to rebuild edges with Belzona 4111 ,
- * Grate replaced over the trench ,
- * One year later, still performing well ,

The application was carried out in accordance with Belzona Know-How System Leaflet FPA. Loose concrete was chipped away and the edges were ground. A wood former was used to rebuild the edges to the original width and height.

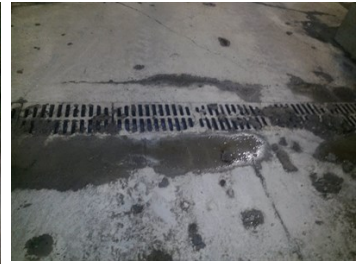
One year later, the drain is in perfect condition. A conventional repair would have cost 10 times more and eliminated the use of the
