# BELZONA SMOOTHS AIRPORT RUNWAY

ID: 5685

Customer Location: Airport, Northern Texas, USA  
Application Date: 2014

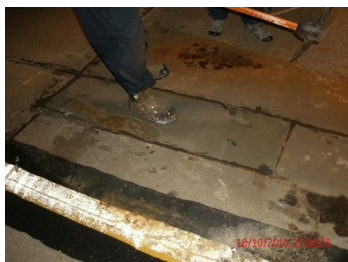
Prior patching material failed. A steel plate was used to cover the hole.

- \* Old patch failed and removed ,
- \* Hole prepared for application ,
- \* Bulk material to fill the hole ,
- \* Finished with pure Belzona 4111 ,

The application was carried out in accordance with Belzona Know-How System Leaflet FPA. Old and loose material was removed. Then, a mixture of gravel and Belzona 4111 was used to bulk up the patch. A batch of pure Belzona 4111 was used to finish the job.
