BELZONA TAKES THE SLIP OUT OF THE FLOOR

ID: 5686

Application: FPA-Floor Problem Areas

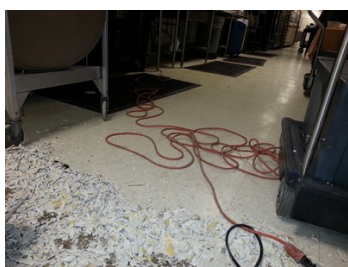
The VCT square tiles were coming up with the water dripping on them from the ice machine, causing a sanitary and slipping problem.

- * Tile removed ,
- * Floor levelled with Belzona 4131 ,
- * Coated floor prepared for nonskid ,
- * Completed floor application ,

The application was carried out in accordance with Belzona Know-How System Leaflet FPA. The tile was removed and the floor was levelled with Belzona 4131. A coat of Belzona 5811 was applied over the whole area and a coat with aggregate was applied in front of the ice machine.
