BELZONA REPAIRS DAMAGED GEAR BOX

ID: 569

Service vehicle gear box

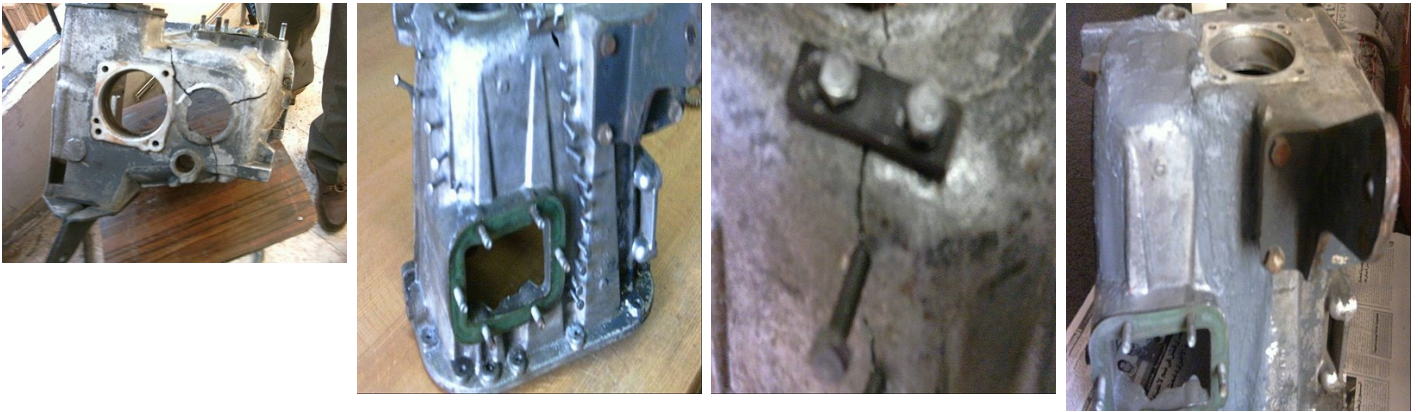
Photograph Descriptions

The gear box was badly cracked and fractured.

- * Fractured gear box ,
- * Stabilizing the long cracks of the gear box ,
- * Using metal strips to reinforce the crack ,
- * Repair completed after applying Belzona® 1111 to the cracked surface ,

Application was carried out in accordance with Belzona Know-How System Leaflet ENC-1 and ENC-3a. The original dimensions were restored then Belzona® 1111 was used in conjunction with Belzona® 9341 to complete the repair, finally bearing housing was bored to its dimensions.

The gear box had many long deep cracks which were dangerous to be welded due to heat distortion and the high ability to fail again. Belzona repair was completed quickly, safely, without heat, and at a moderate price.
