CLARIFIER HEADWORKS GET QUICK FIX WITH BELZONA

ID: 5702

Customer Location: Waste Treatment Plant, Northern Texas, USA

Application: TCC-Tanks and Chemical Containment Areas

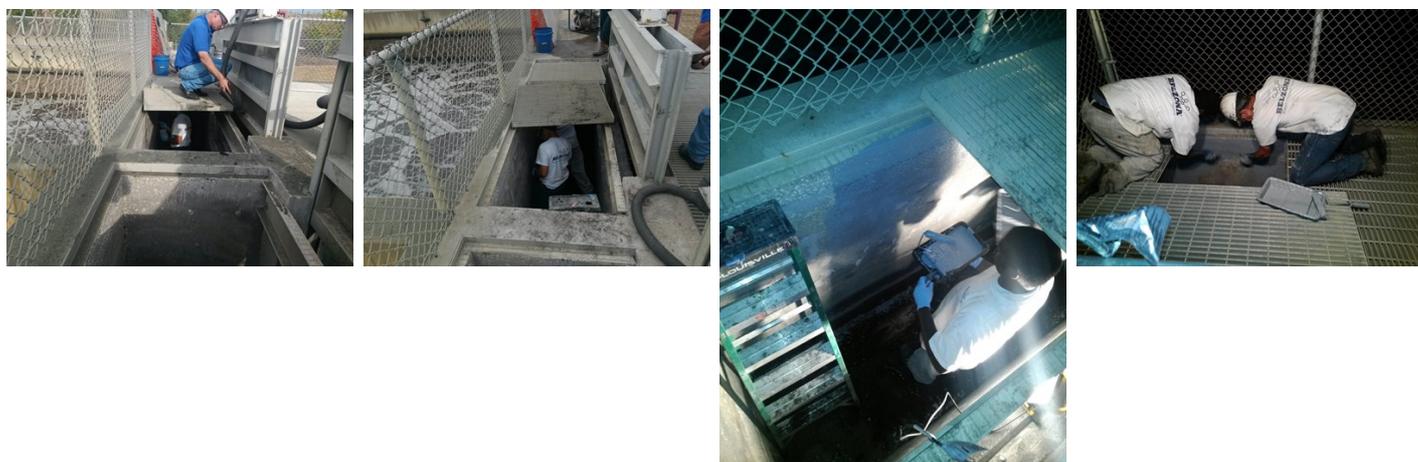
Photograph Descriptions

The headworks of a clarifier were covered with a plate to reduce H2S odor. This caused chemical attack to the concrete.

- * Blasting the headworks ,
- * Bugholes filled with Belzona 4111 ,
- * Application of the first coat of Belzona 5831 ,
- * Application of the final coat of Belzona 5831 ,

Chemical attack to headworks of clarifier.

The application was carried out in accordance with Belzona Know-How System Leaflet TCC. The concrete was blasted and bugholes were filled with Belzona 4111. Two coats of Belzona 5831 were then applied.

The headworks could not be coated with a competitor since it required a 3 day cure. This job was completed in just 12 hours and returned to service to let Belzona 5831 cure under water.
