# CLARIFIER HEADWORKS GET QUICK FIX WITH BELZONA

Customer Location: Waste Treatment Plant, Northern Texas, USA

Application: TCC-Tanks and Chemical Containment Areas

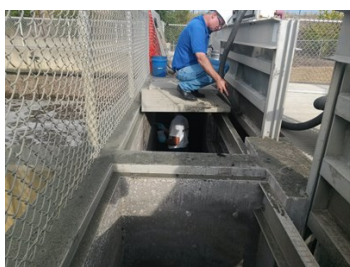
- \* Blasting the headworks ,
- \* Bugholes filled with Belzona 4111 ,
- \* Application of the first coat of Belzona 5831 ,
- \* Application of the final coat of Belzona 5831 ,

The application was carried out in accordance with Belzona Know-How System Leaflet TCC. The concrete was blasted and bugholes were filled with Belzona 4111. Two coats of Belzona 5831 were then applied.
